SAFETY ALERT

Safety Alert No. 317
12 June 2015

CATASTROPHIC INCIDENT AVOIDED

Failure to communicate hazards and to provide adequate management oversight during a critical lift resulted in equipment damage and the near miss of a catastrophic incident.

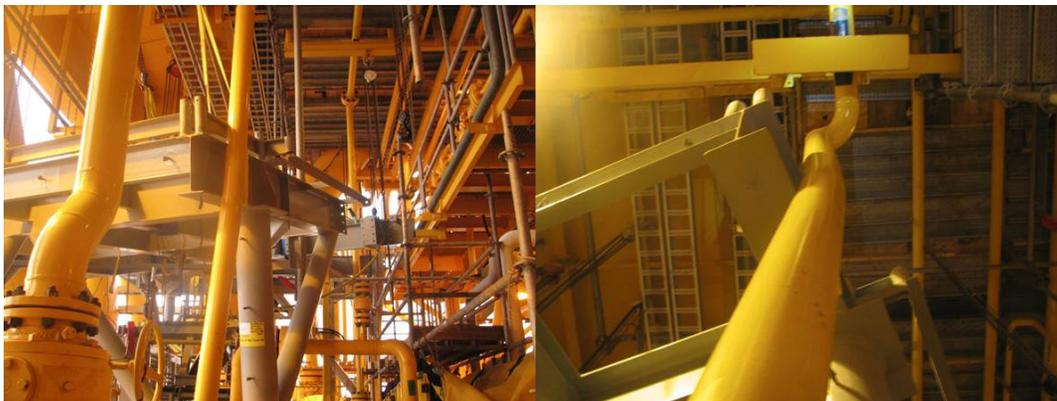
During the installation of a gas lift mezzanine deck on a deep water floating facility, the 6,500 pound structure shifted unexpectedly. This shift caused the load to jam between an existing, high pressure gas lift piping and a 4-inch valve, damaging the still-pressurized gas line and gouging the 4-inch valve body. In a subsequent attempt to free the active gas lift piping, the lifting crew performed a cold cut on a U-bolt brace without a change request or permits to work. A rupture of the line or valve could have led to a significant gas release, fire and/or explosion. The Offshore Installation Manager (OIM) averted disaster by stopping the job during a regular inspection walk on the platform.

Deck against Gas-Lift Line

Bowed Gas-Lift Line

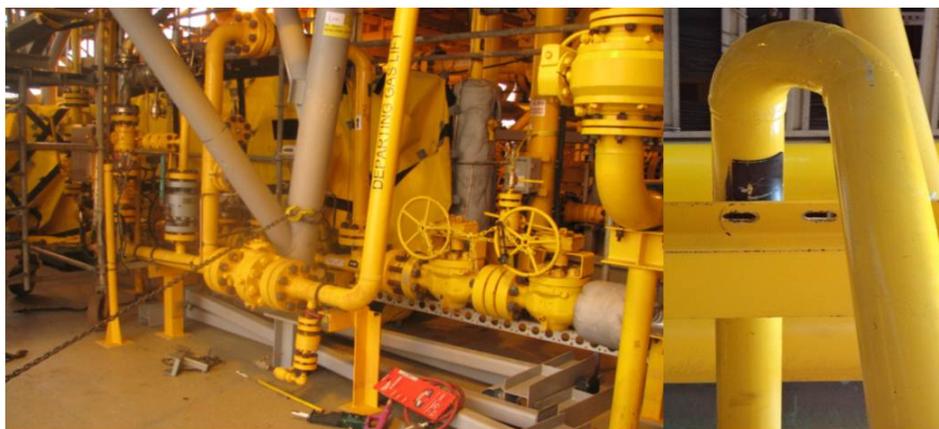
Deck Jammed Between Gas-Lift Line

U-bolt Cut

- Changes were made during the work activity (e.g. cutting the U-bolt brace) without first analyzing the potential hazards or notifying other personnel onboard the facility.
